# Moa Point Wastewater Treatment Plant

## flood incident: Independent review

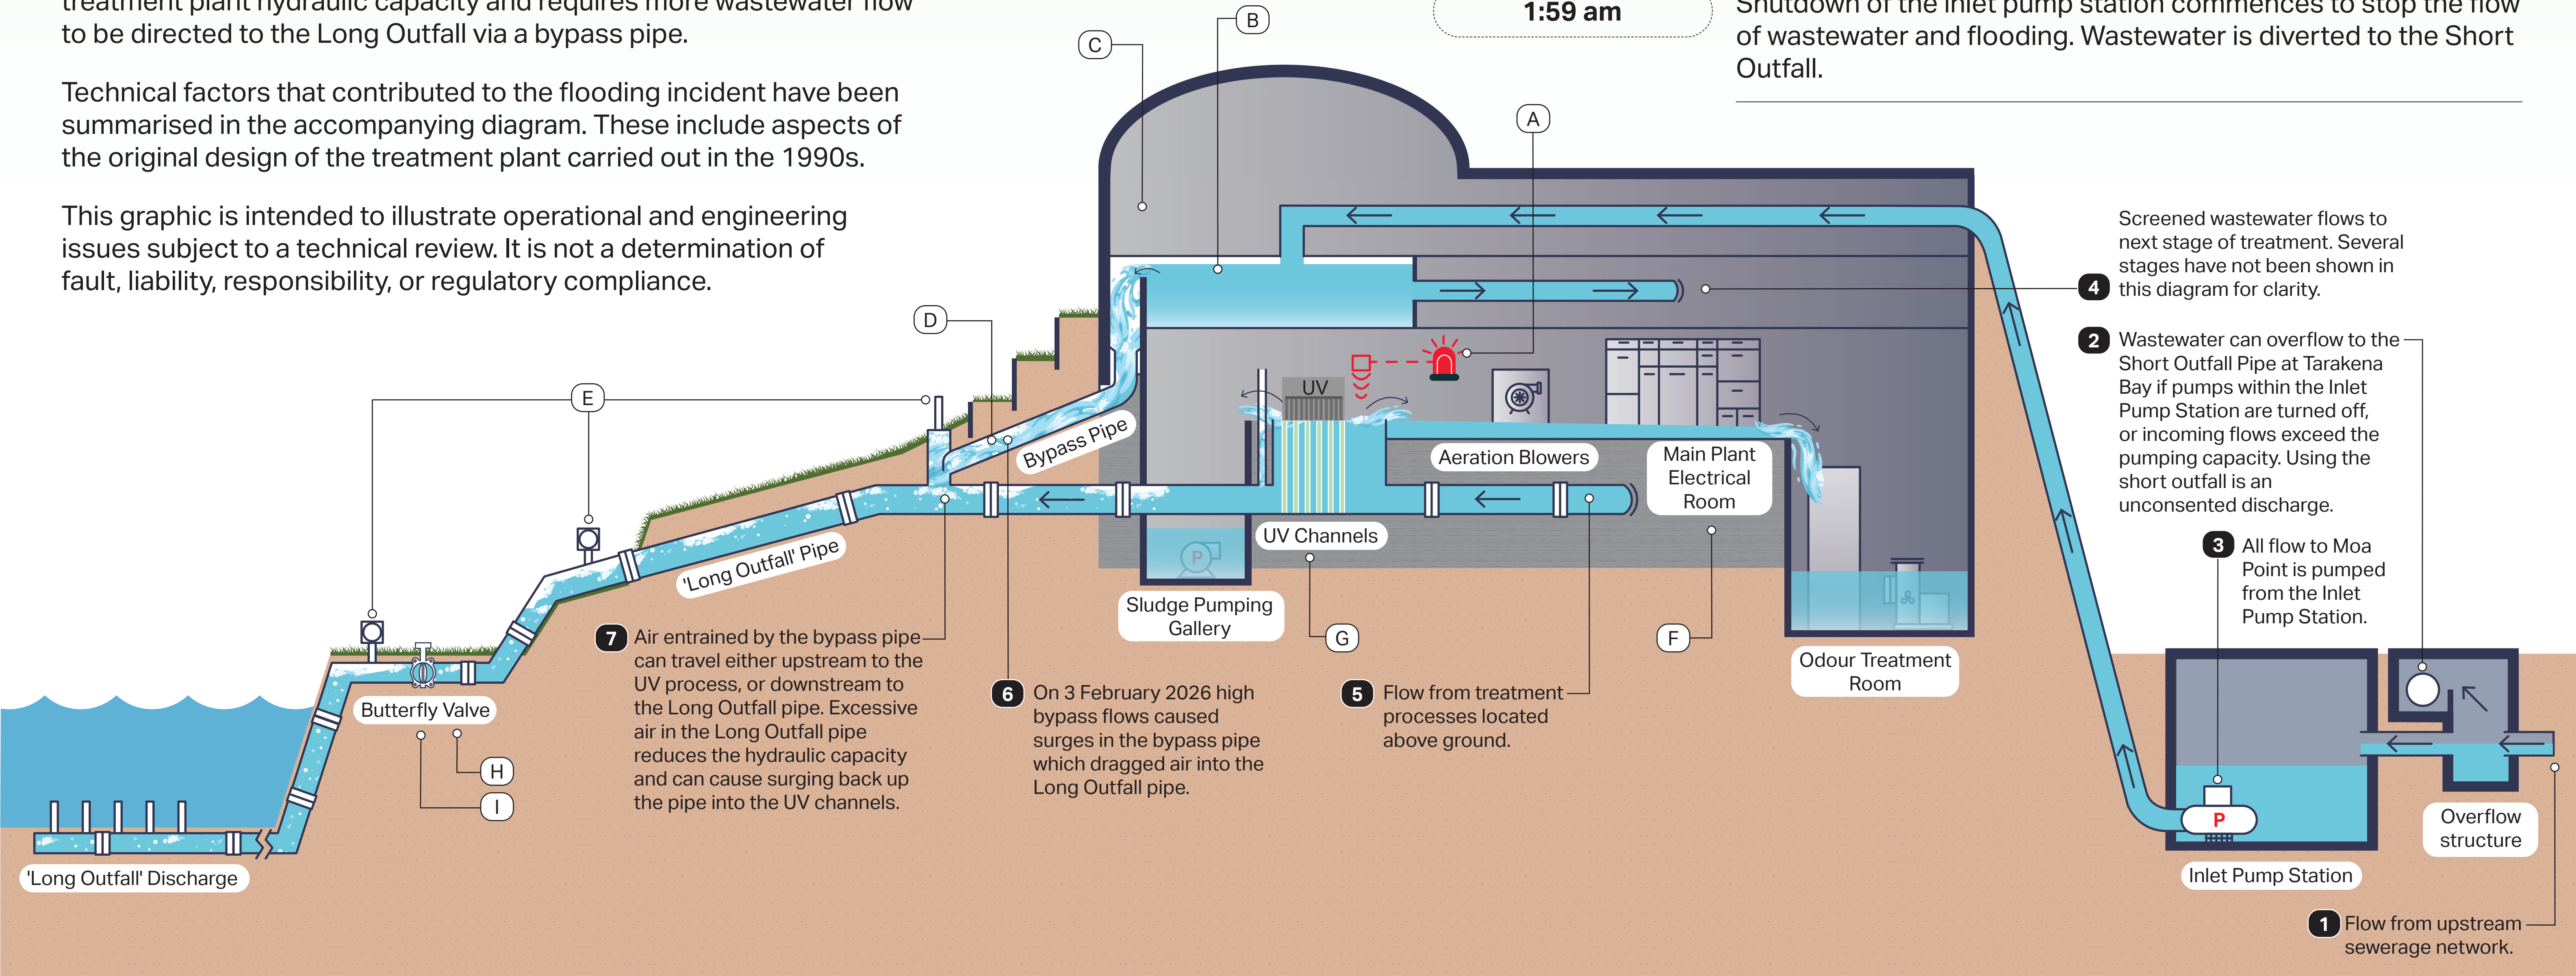
Technical factors that contributed to the flooding incident have been summarised in the accompanying diagram. These include aspects of the original design of the treatment plant carried out in the 1990s.

Wastewater flow to the treatment plant reaches 3,400 litres per second. Surges in flow down the bypass pipe dragged air into the Long Outfall pipe causing a restriction in capacity.

The operating UV channel overflows, flooding of structures located underground begins.

| <p><b>A</b> Design documentation reviewed from the original 1990s design did not include or <b>infer</b> any need for level sensors with high level alarms to alert staff to high water levels in the UV room, or <b>to</b> stop flow from the Inlet Pump Station.</p> | <p><b>D</b> The original 1990s design implies that the bypass pipe is intended to handle 4,000 litres per second of flow. Hydraulic calculations reviewed from the original 1990s design do not appear to consider the combined, bypass pipe, Long Outfall and wastewater treatment plant system. They also do not appear to test the scenario where 4,000 litres per second is directed through the bypass pipe.</p> | <p><b>G</b> Early design concepts for the wastewater treatment plant included four UV channels. Between these early concepts and the 1994-96 design, the number of UV channels was reduced two. Documentation reviewed from the 1994-96 design indicates that the intent was to increase the capacity of the UV process by making structural changes to the two UV channels and modifications to UV equipment, when required in the future. However, the documentation does not describe how this was to occur without a reduction in UV hydraulic capacity, which would lead to increased flows being directed to the bypass pipe. This meant a redundant UV channel was not available to maintain hydraulic and treatment capacity during the eventual replacement of UV equipment in 2026.</p> |
| <p><b>B</b> Design documentation reviewed from the original 1990s design indicates the treatment process was designed for 3,000 litres per second of flow, the Inlet Pump Station was designed for 4,000 litres per second of flow, the bypass pipe is intended to handle 4,000 litres per second of flow and the Long Outfall pipe was designed to handle 4,500 litres per second of flow. During the flooding incident the bypass flow did not exceed 2,300 litres per second.</p> | <p><b>E</b> Air relief valves and vents along the Long Outfall pipe, while <b>consistent</b> with the original design, may not be of an appropriate size or type and may not have released air fast enough. This is currently under investigation. The purpose of the air relief valves is to release air from the Long Outfall pipe, so the air does not restrict the flow of the wastewater.</p> | <p><b>H</b> Potential downstream obstructions may have contributed to the flooding incident. These are currently under investigation.</p> |
| <p><b>C</b> Design documentation reviewed from the original 1990s design did not identify the risk of surges and/or air entrainment in the bypass pipe. Air entrainment is a process where air is mixed with a liquid (e.g., wastewater). It occupies pipe volume and can restrict the flow of wastewater in a pipe.</p> | <p><b>F</b> The original design and construction in the 1990s placed critical infrastructure (such as the main plant electrical room), below ground and within overflow pathways without flood protection barriers, suggesting that the risk of flooding to lower levels of the plant was considered to be low during the design process or due to the physical constraints of the site.</p> | |
