# Water Services Delivery Plan

Waitaki District Council

9 June 2026

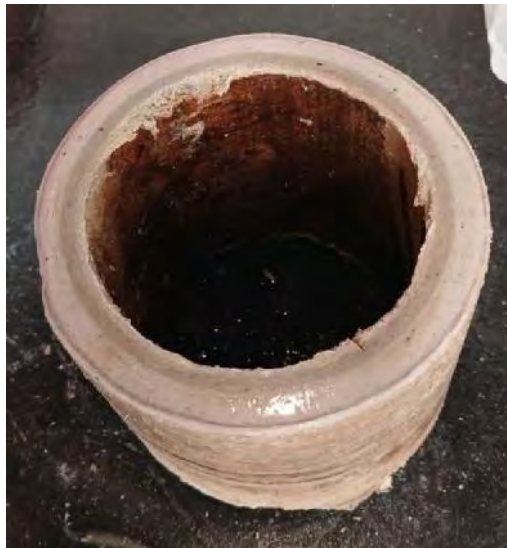
Fig 1: represents pipe asset ID WFROU857B

**Results:** No change in colour was observed for pipe wall thickness as shown in Fig 1.  
The pipe has experienced through-thickness deterioration.

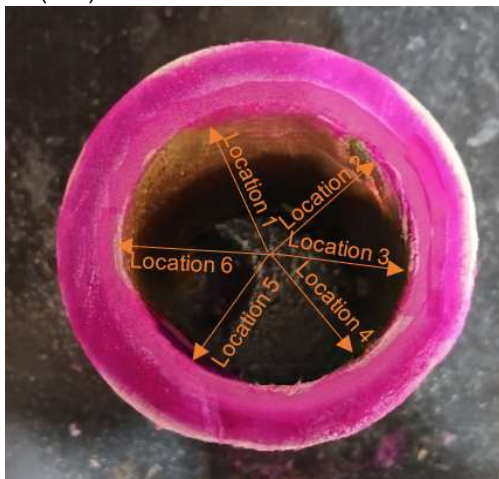
Fig 1: represents pipe asset ID WVOAK003-WNOAKO21A

Max. External deterioration(mm): 2.2

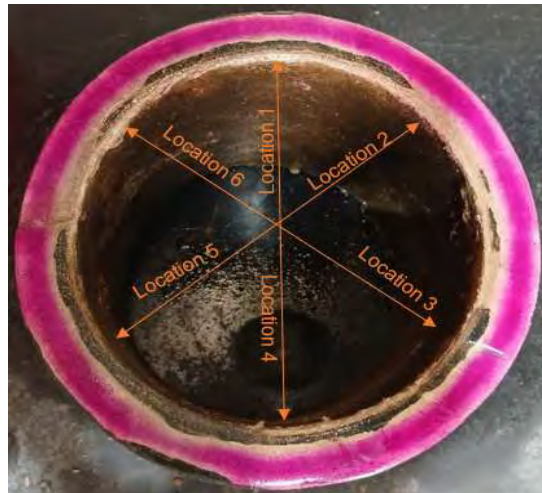
Fig 1: represents pipe asset ID WVOAK005 - WNOAK021

Max. External deterioration(mm): 1.4

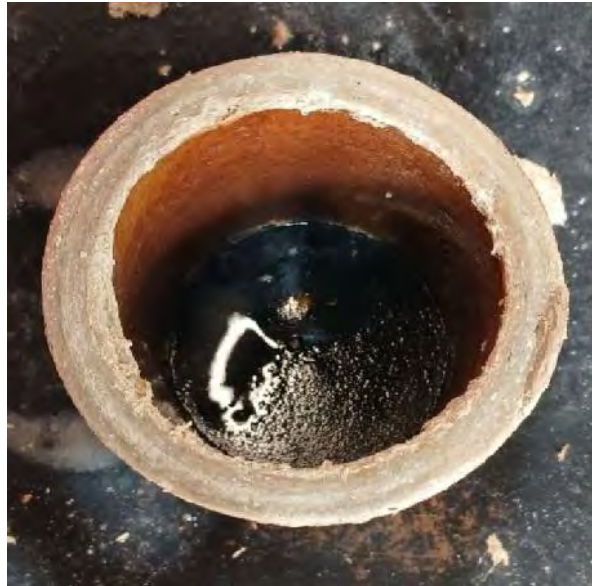
Fig 1: represents pipe asset ID WNHOM205

**Test:** Phenolphthalein test on asbestos cement pipes.  
**Equipment:** Digital callipers: Mitutoyo S/N 05662947  
**Sample Prep:** Hand polish with 120 grit sandpaper.  
**Pipe Dimensions:** Nominal OD: 96mm  
**Results:** No change in colour was observed for pipe wall thickness as shown in Fig 1.  
The pipe has experienced through-thickness deterioration.

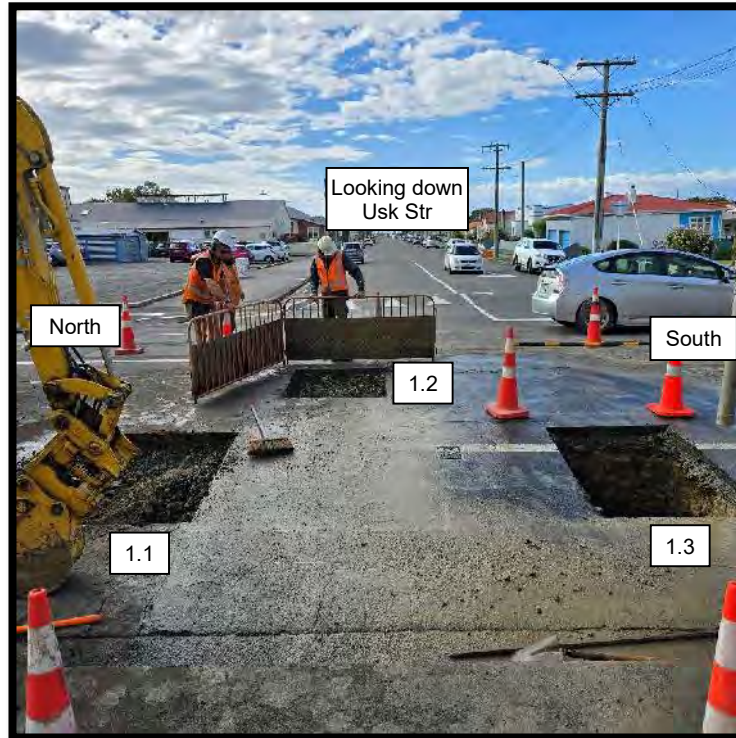
Photo below for location purpose of pipework located at Reed / Usk intersection.

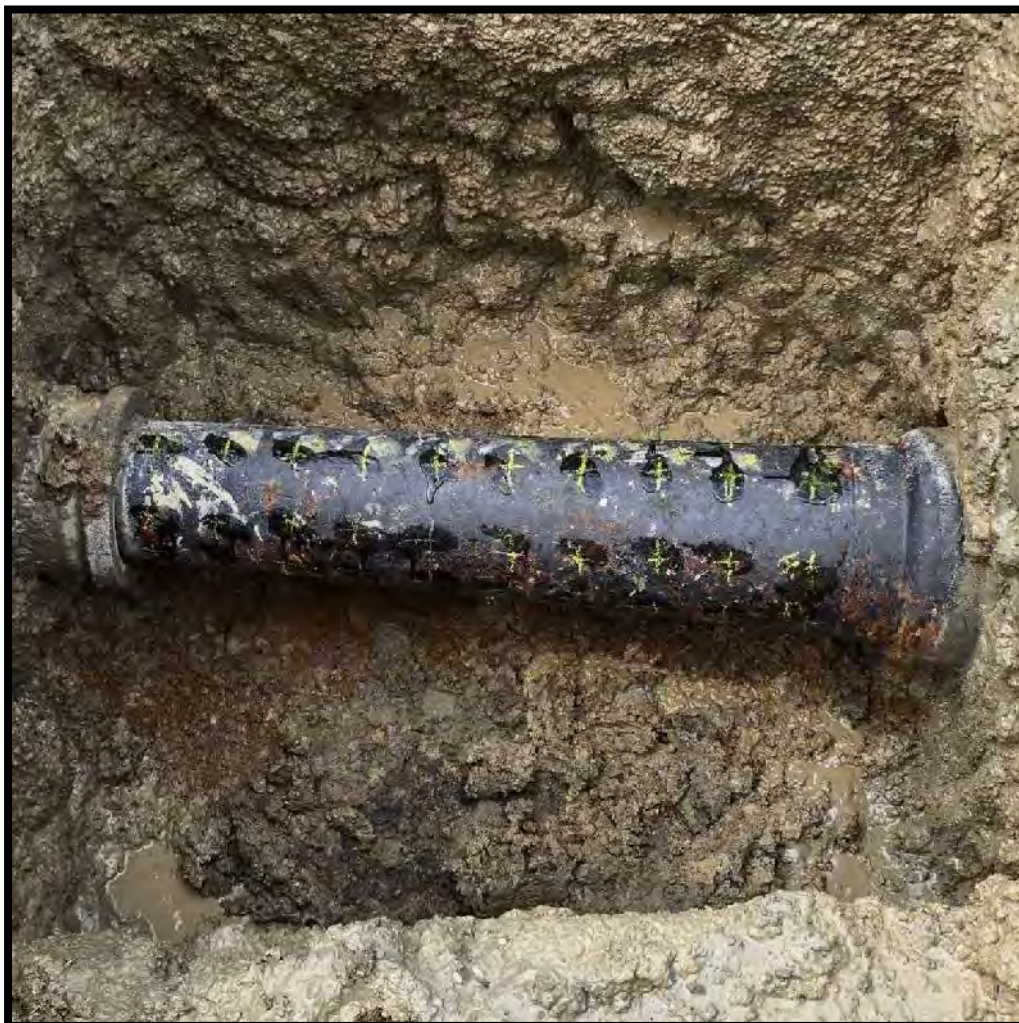
Grid size used on pipework is 100x100mm

| Position | A | B | C | D | E | F | G | H | Min: | Max: | Ave: |
|---|---|---|---|---|---|---|---|---|---|---|---|
| All values in mm | | | | | | | | | 12.52 | 23.14 | 19.11 |

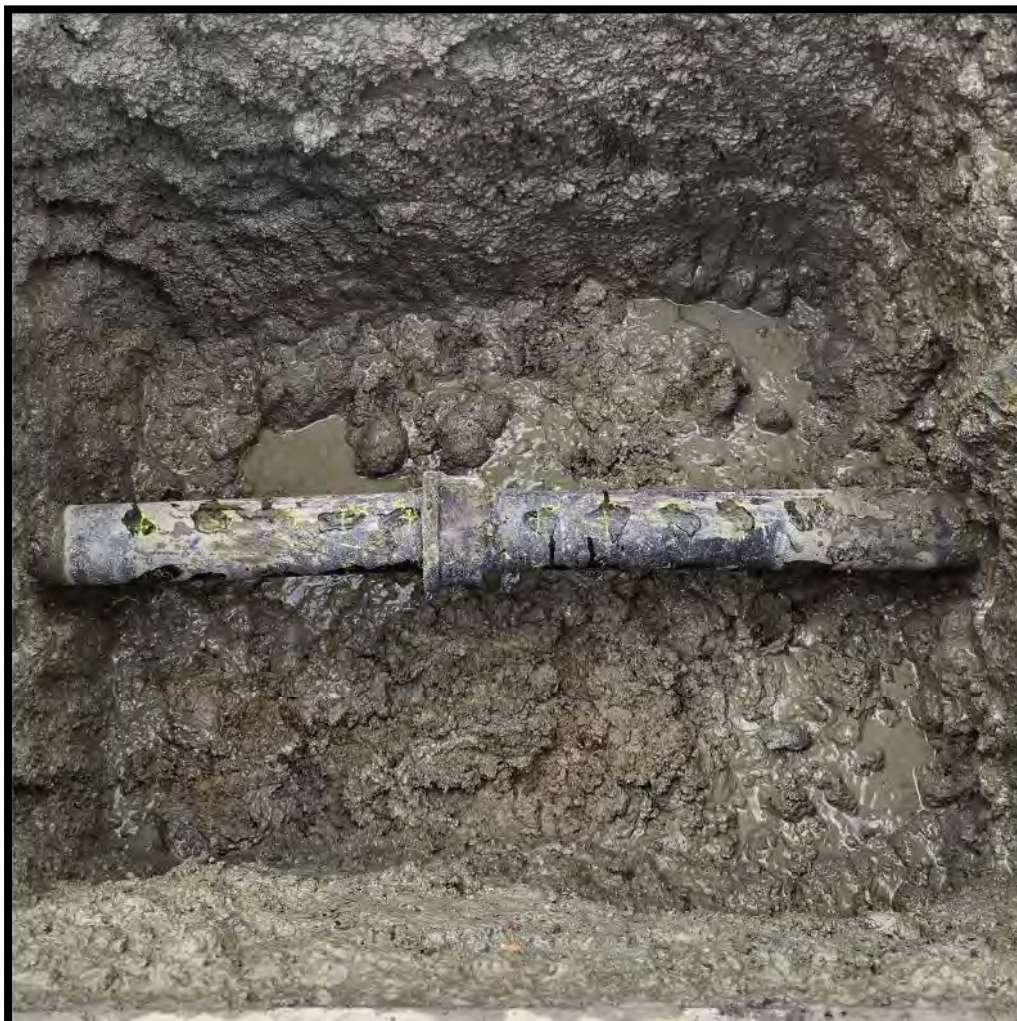
**1.2 Reed Str / Usk Str intersection – Looking down Usk Str**

| Position | A | B | C | D | Min: | Max: | Ave: |
|---|---|---|---|---|---|---|---|
| All values in mm | | | | | 10.14 | 15.55 | 12.81 |

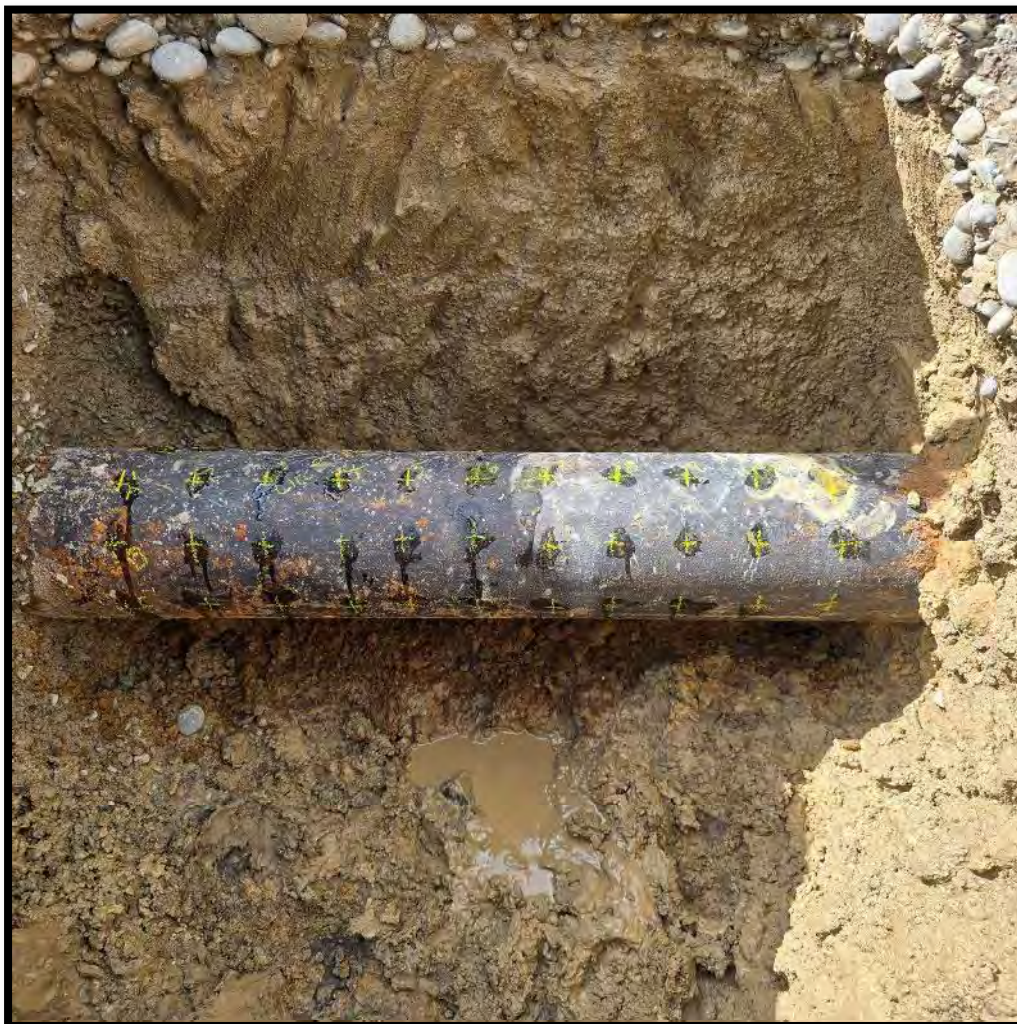
### 1.3 Reed Str / Usk Str intersection – South

| Position | A | B | C | D | E | F | G | H | Min: | Max: | Ave: |
|---|---|---|---|---|---|---|---|---|---|---|---|
| All values in mm | | | | | | | | | 12.35 | 20.31 | 16.46 |

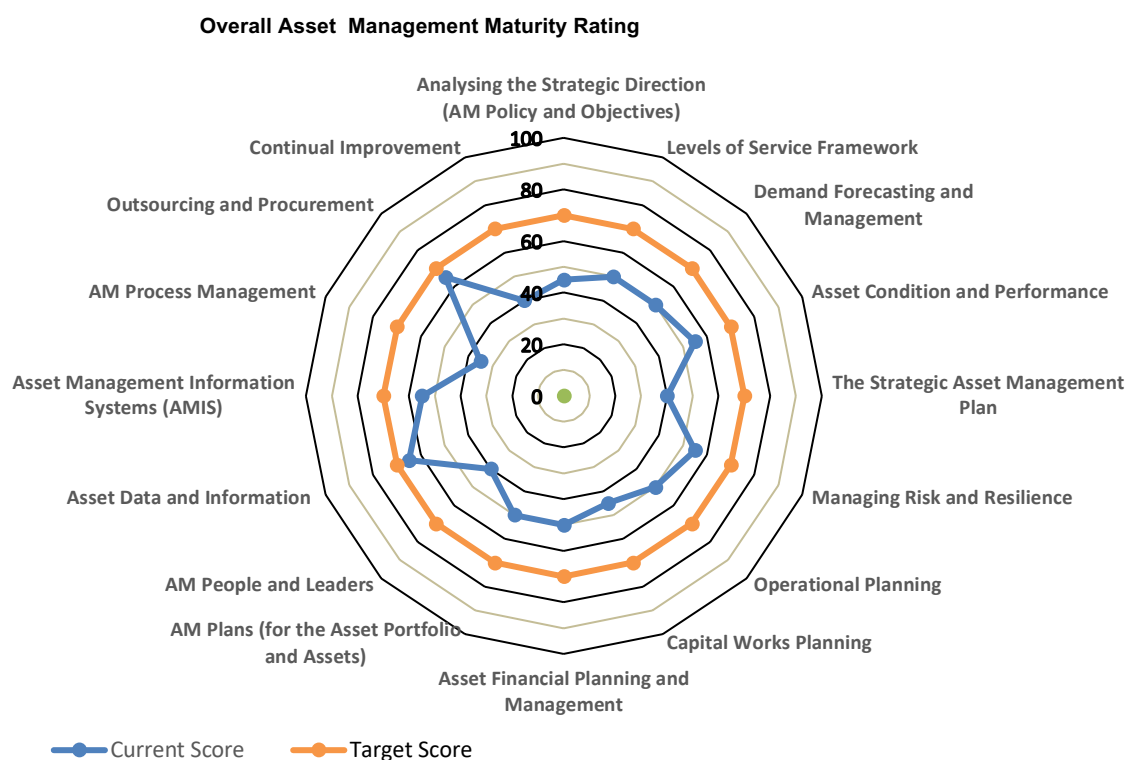
### 3.1.3 Maturity assessment graphs

Due to relative consistency in asset management practices across WDC's 3 waters activities, results have been aggregated into singular graphs.
